REHABILITATION OF REINFORCED CONCRETE BEAMS BY USING MATERIALS GFRP, CFRP AND BONDING STEEL PLATE

ABSTRACT: This research paper shows that materials GFRP (glass fiber reinforced polymer) CFRP (carbon fiber reinforced polymer) and bonding steel plate, were used to rehabilitate 12 numbers of reinforced concrete (RC) beam of size 75x150x1750mm for M20 grade of concrete. These were distressed in flexure by adopting a_v/d ratio 3 and 4 under two point loading conditions by taking 90% of the ultimate load. Then, these distressed beams were repaired and retested up to failure. The aim of this study is to determine the suitability of best rehabilitate material type to be used in RC beams for repairing and restoring good strength and for considering economical aspects. Hardened concrete specimens were tested for compression and flexure test. The results of these experiments show that beams repaired using bonding plate gave less deflection than other two materials. The flexural strength increased significantly up to 13% for concrete beams repaired with bonding plate similarly, flexural strength increased up to 10% for GFRP and 8% for CFRP.

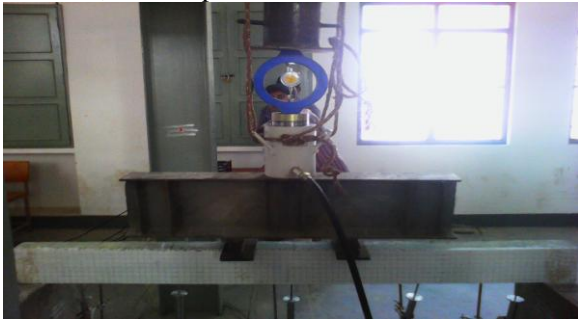
Adopt $a_v/d = 3$ and 4
 $a_v =$ shear span

Fig 1: loading arrangement of beams

Moulds were removed after 24 hours and the specimens were placed for curing. Three dial gauges were fixed at bottom in order to record the strains. Three gauges were fixed below the beam at middle third and midspan to observe the deflections. The beams were tested in a Universal Testing Machine under two point loading at middle third points of the span. The whole set up was placed with Universal Testing Machine of 200 ton capacity and subjected to two points loading.

The load is applied in small increments and the dial gage readings are taken every 4kN until failure occurs. The deflections are recorded at each level of loading. Cracks are detected and their widths are recorded at several levels of loading. Figure (2) shows the loading arrangement used throughout the tests.

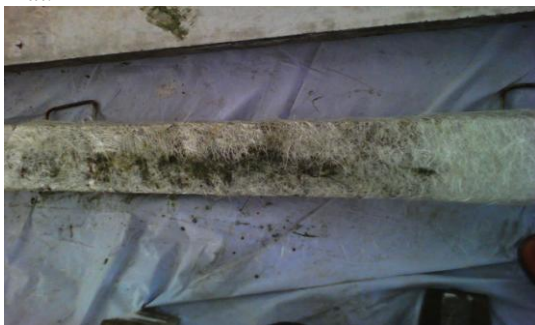
Fig.2 shows that after fully wrapping of beam by using GFRP

The surface for application must cleaned and made free from dirt, grease oil and loose particles before application of GFRP resins, thoroughly removed the dirt's by any mechanical means. Firstly albumin 15ml mix with 1 liter resin and then catalyst 16ml mix with those mixtures. Sealing the crack by using those mixtures after 1hour give one coating to that beam. After wrapping the beam by using glass fibers mat.

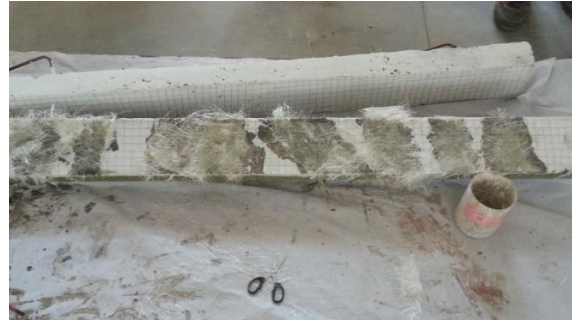
Fig.3 shows that after Partially wrapping of beam by using GFRP

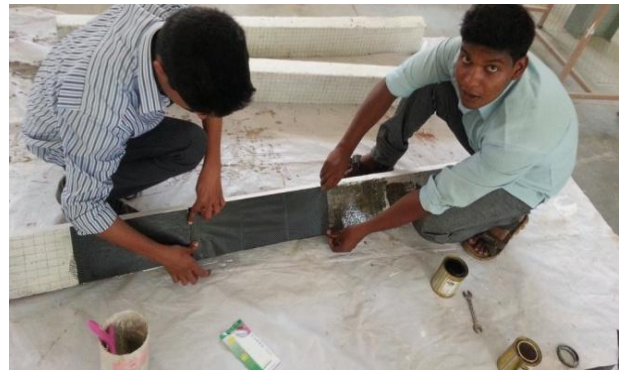
Fig.4 shows that Wrapping of beam by using CFRP

The surface for application must cleaned and made free from dirt, grease oil and loose particles before application of CFRP resins, thoroughly removed the dirt's by any mechanical means. Firstly albumin 15ml mix with 1 liter resin and then catalyst 16ml mix with those mixtures. Sealing the crack by using those mixtures after 1hour give one coating to that beam. After wrapping the beam by using Carbon fibers mat.

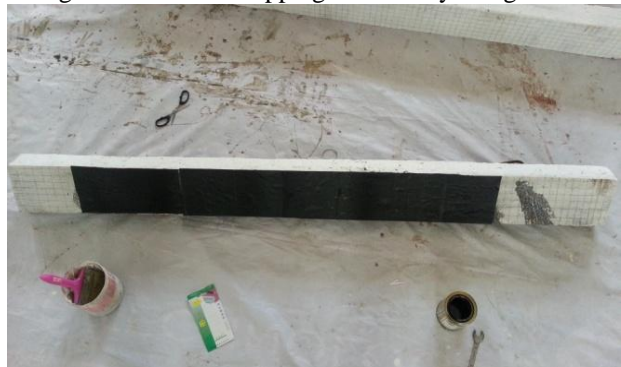
Fig.5 shows that Partial Wrapping of beam by using CFRP

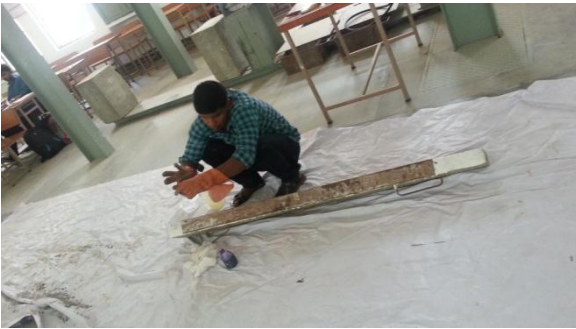
Fig.6 shows that Partial Wrapping of beam by using Bonding plate

The surface for application must cleaned and made free from dirt, grease oil and loose particles before application of FRP resins, thoroughly removed the dirt's by any mechanical means. Firstly albumin 15ml mix with 1 liter resin and then catalyst 16ml mix with those mixtures. Sealing the crack by using those mixtures after 1hour give one coating to that beam. After wrapping the beam by using Bonding steel plate.

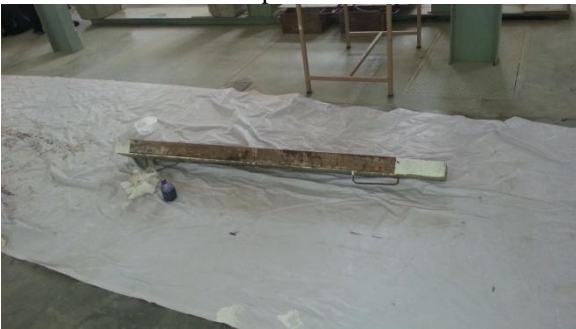
Fig.7 shows after Wrapping of beam by using bonding steel plate

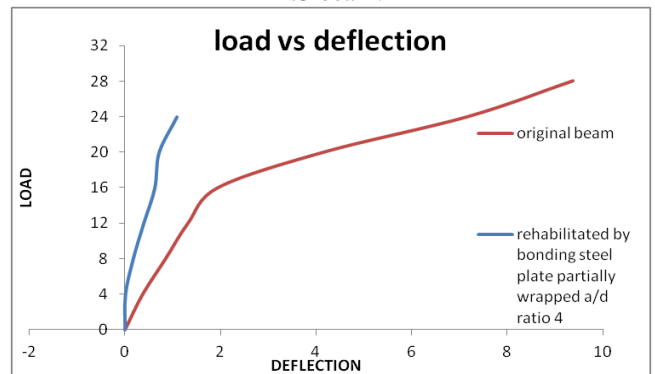
Fig.17 shows that Load vs deflection for original beam and Ps4 beam.

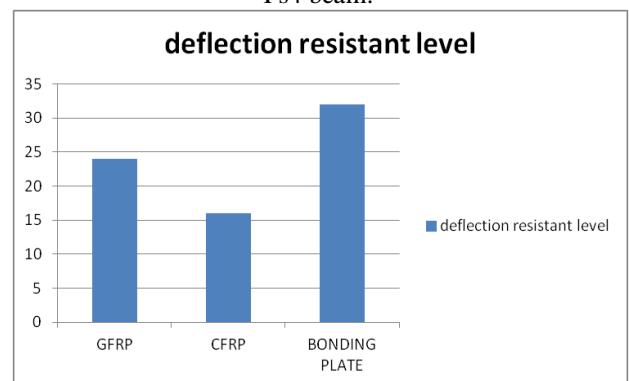
Fig.18 Bar Chart shows Deflection tolerance for each material used based on ultimate load

From this result bonding plate gives better strength among the other.
