# STRUCTURAL AUDIT, REPAIR AND REHABILITATION OF BUILDINGS

Basit Bashir Dar<sup>1</sup>, Mohd. Suhail Khan<sup>2</sup>

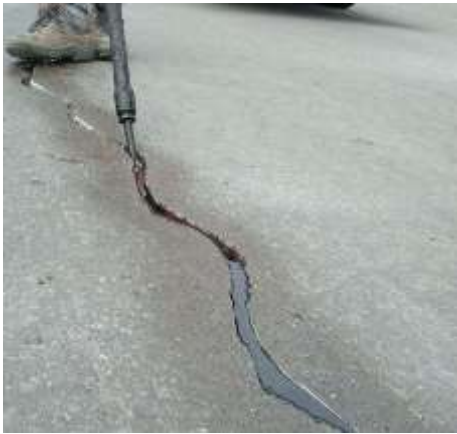
Routing and sealing is a common method of repairing dormant cracks. The procedure should not be used on active cracks. A minimum surface width for a crack to be routed and sealed is one-quarter inch. When you are dealing with pattern cracks or narrow cracks, the routing will enlarge the cracks to make them suitable for sealants. Sealants are used to prevent water infiltration. This involves enlarging the crack along its exposed face and sealing it with crack fillers. Care should be taken to ensure that the entire crack is routed and sealed. Routing and sealing of cracks can be used in conditions requiring remedial repair and where structural repair is not necessary. This method involves enlarging the crack along its exposed face and filling and sealing it with a suitable joint sealant (Fig.(e)). This is a common technique for crack treatment and is relatively simple in comparison to the procedures and the training required for epoxy injection. The procedure is most applicable to approximately flat horizontal surfaces such as floors and pavements. However, routing and sealing can be accomplished on vertical surfaces (with a non-sag sealant) as well as on curved surfaces (pipes, piles and pole).
