CASE STUDY ON FLEXIBLE PAVEMENT FAILURES ON DODA BHADERWAH ROAD (NH-1B) AND ITS REMEDIAL MEASURES

The condition of pavement between Doda to Bhaderwah is not good enough so that it requires some maintenance and rehabilitation. Road length of 20.0kms from Doda to Bhaderwah (NH-1B). it is the only road which connects Bhaderwah with Himachal Pradesh. The nearby area is mostly agricultural land and remains irrigated throughout the year. Many schools, marriage halls, colleges and residential areas are existing on the stretch, so the traffic volume will increase year by year. There are many college buses, loaded trucks, tractors, public transport travelling 24 hours on the length of road. So the pavement condition shall deteriorate under failing circumstances and unsafe for road users due to heavy traffic.

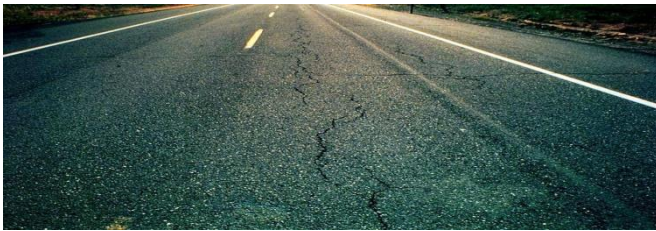
Fig. 4.5.2 Longitudinal Cracking

The longitudinal cracks are parallel slits to the pavement’s centerline; these cracks are structural defects and Functional defects. The loads and moisture accelerate the deterioration of these cracks.

Section	Type of Distress	Length (mm)	Width (mm)	Severity Levels
PulDoda to Pranoo	Longitudinal cracking	1750	4.8	Low
Pranoo to Bhalla		1820	11.9	Moderate and Low
		1360	2.4	
Bhalla to Khellani		1710	4	Low
Khellani to Seri		950	3.9	Low

The longitudinal cracking in section PulDoda to Pranoo, Pranoo to Bhalla, Bhalla to Khellani and Khellani to Seri are of low severity levels. So, the suggested maintenance is Crack seal to prevent moisture entering into subgrade through the cracks. Provide side drainage ditches to reduce cracking.

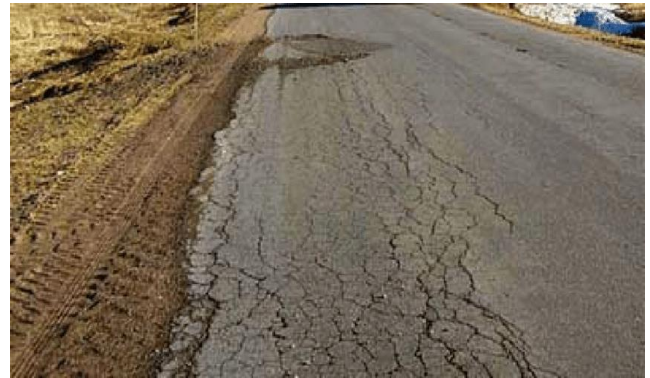
Fig. 4.5.3 Edge Cracking

Edges cracking generally are parallel to the edge of the pavement. The shape of cracks is crescent or fairly continuous cracks. Edge cracks are increased due to excess traffic loads.

- Low: Cracks with no breakup or loss of material.
- Moderate: Cracks with some breakup and loss of material for up to 10% of the length of the affected portion of the pavement.
- High: Cracks with considerable breakup and loss of material for more than 10% of the length of the affected portion of the pavement.

Section	Type of Distress	Length (mm)	Severity Levels
PulDoda to Pranoo	Edge Cracking	1120	Moderate
		1210	Low
Pranoo to Bhalla		1580	High
Bhalla to Khellani		570	High
Khellani to Seri		1235	Moderate

- Improve drainage. Remove vegetation close to edge.
- Reconstruct of the edge and support the edge with paving stones.

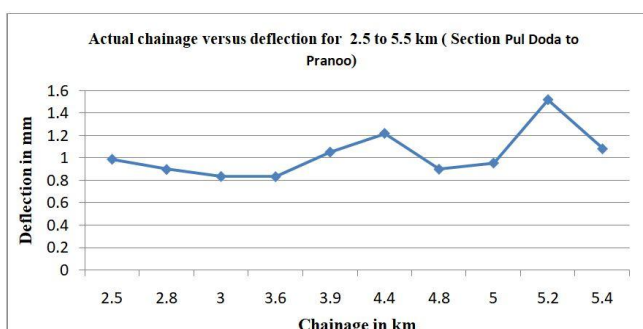
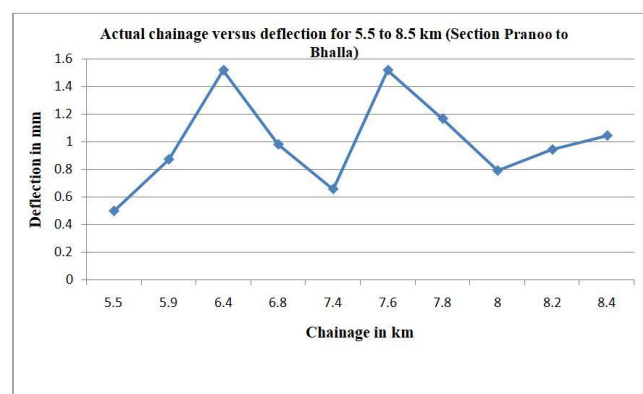
Fig.4.6 Variation of deflection with chainage

Pranoo to Bhalla							
1	0L	36	2.6	2.71	2.76	0.455	0.5005
2	50R	36	3.6	3.81	3.86	0.811	0.8151
3	100L	36	4.5	4.78	4.81	0.795	0.8745
4	150R	36	4.6	4.88	4.88	0.56	0.539
5	200L	36	2.9	3.2	3.3	1.382	1.5202
6	250R	36	6.3	6.6	6.64	0.913	0.9273
7	300L	36	4.3	4.59	4.63	0.893	0.9823
8	350R	36	1.3	1.65	1.68	0.935	0.9515
9	400L	35	5.6	5.7	5.9	0.60	0.66
10	450R	35	6.3	6.56	6.6	0.833	0.8393
11	500L	35	5.6	5.9	6.0	1.382	1.5202
12	550R	35	7.3	7.49	7.53	0.693	0.6853
13	600L	36	6.3	6.4	6.4	0.20	0.209
14	650R	37	6.4	6.81	6.85	1.133	1.1693
15	700L	37	1.3	1.62	1.65	0.875	0.9515
16	750R	37	4.6	4.8	4.85	0.791	0.7931
17	800L	37	1.3	1.49	1.57	1.0056	1.09516
18	850R	36	5.6	5.83	5.89	0.9292	0.94512
19	900L	35	1.6	1.83	1.87	0.7728	0.83908
20	950R	35	4.0	4.31	4.36	1.011	1.0461

Bhalla to Khellani							
1	0L	36	2.3	2.51	2.59	1.0456	1.128804
2	50R	36	3.4	3.59	3.63	0.693	0.68997
3	100L	37	3.0	3.24	3.3	0.9492	1.023728
4	150R	37	2.6	2.76	2.86	0.633	0.62457
5	200L	37	4.6	4.81	4.89	1.0456	1.128804
6	250R	37	2.4	2.61	2.66	0.811	0.81859
7	300L	38	5.6	5.96	5.99	0.955	1.03005
8	350R	38	1.60	1.83	1.89	0.9292	0.94742
9	400L	37	2.4	2.59	2.63	0.693	0.74447
10	450R	37	4.8	5.09	5.15	1.0492	1.078228
11	500L	39	4.9	5.14	5.21	1.0274	1.10896
12	550R	39	7.6	7.81	7.86	0.811	0.81859
13	600L	39	6.3	6.48	6.55	0.9074	0.967266
14	650R	39	4.1	4.42	4.46	0.9528	0.973152
15	700L	39	4.0	4.24	4.29	0.871	0.92759
16	750R	39	5.1	5.37	5.41	0.853	0.86437
17	800L	38	5.6	5.81	5.86	0.811	0.86219
18	850R	38	3.0	3.23	3.29	0.9292	0.958328
19	900L	38	3.2	3.46	3.53	1.0674	1.141666
20	950R	38	5.6	5.81	5.88	0.9674	0.99996
